HAGGARDSTOWN OLD CHURCH CONSERVATION AND MANAGEMENT REPORT

For Blackrock Tidy Towns

November 2020

3. Condition Survey

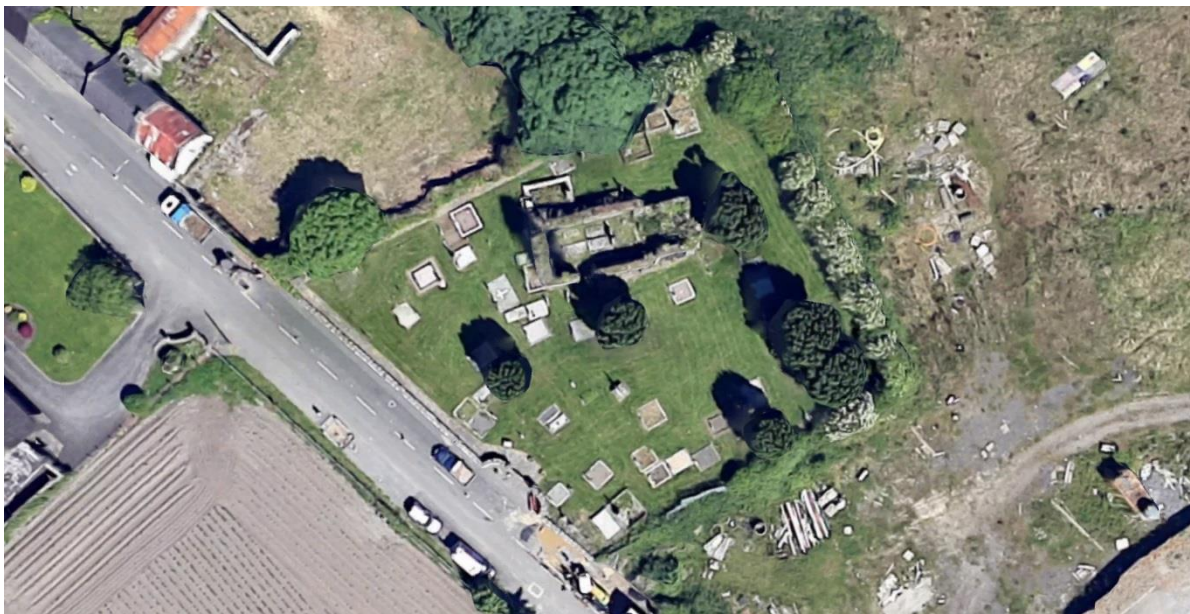
Fig.10: GoogleMaps aerial photograph showing Haggardstown Old Church in a well-maintained graveyard. The image shows vegetation growing along the exposed wall-tops, and collapsed masonry in the chancel.

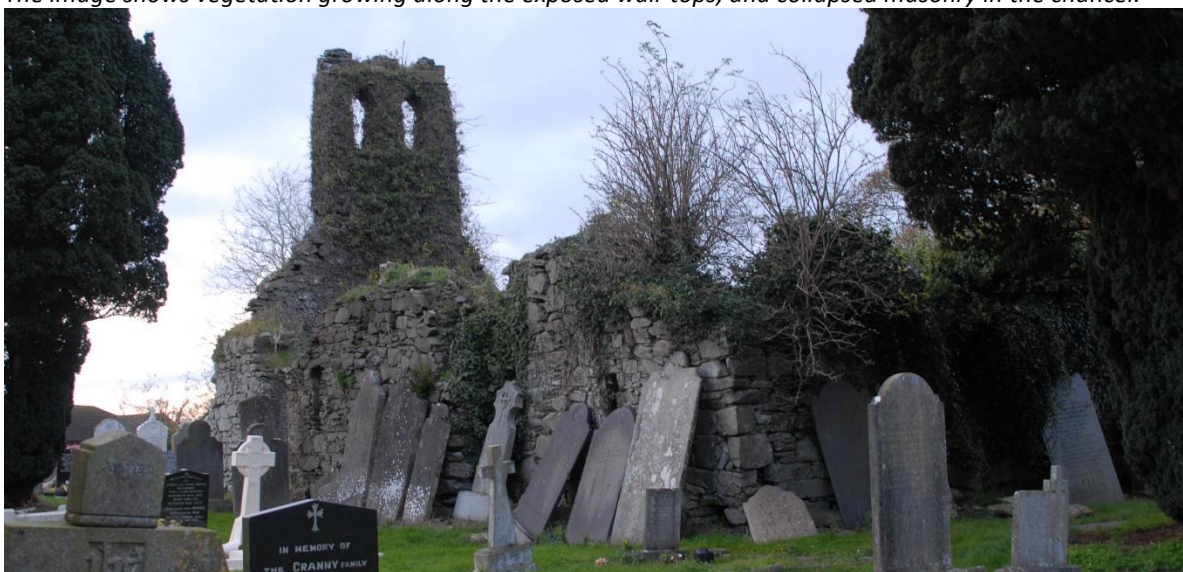
Fig.11: View of Haggardstown Old Church from the south-east showing graveslabs propped against the east and south walls, with ivy and other vegetation at wall-tops and on both internal and external masonry surfaces.

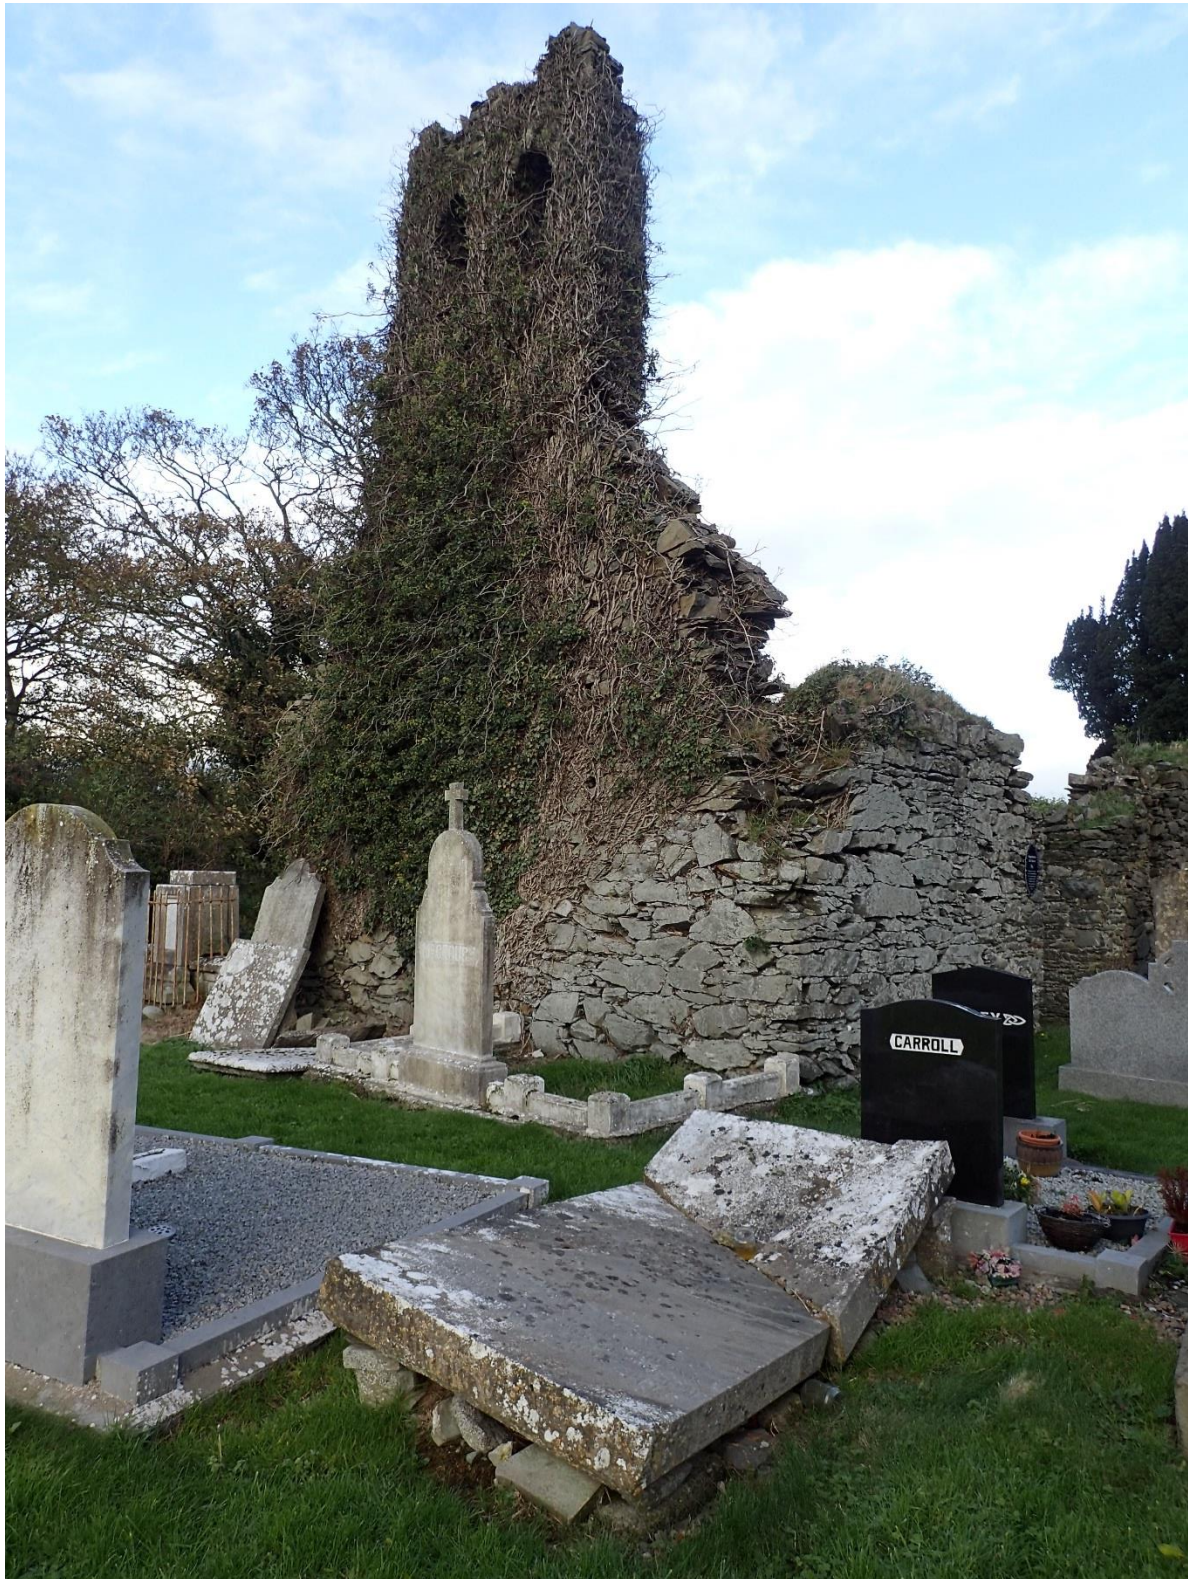
3.1 West Elevation: Gable and bellcote: Much of the gable is coated by ivy, the roots of which have penetrated into the wall fabric. The shoulders of the gable show exposed wall core and loose masonry; both the south-east and north-east corners have lost masonry and there are dry joints and loose stone throughout.

Fig.12: General view of the west elevation showing ivy extending to the head of the bell-cote, and the masonry at the south-west corner broken open exposing the bedding mortars and wall core.

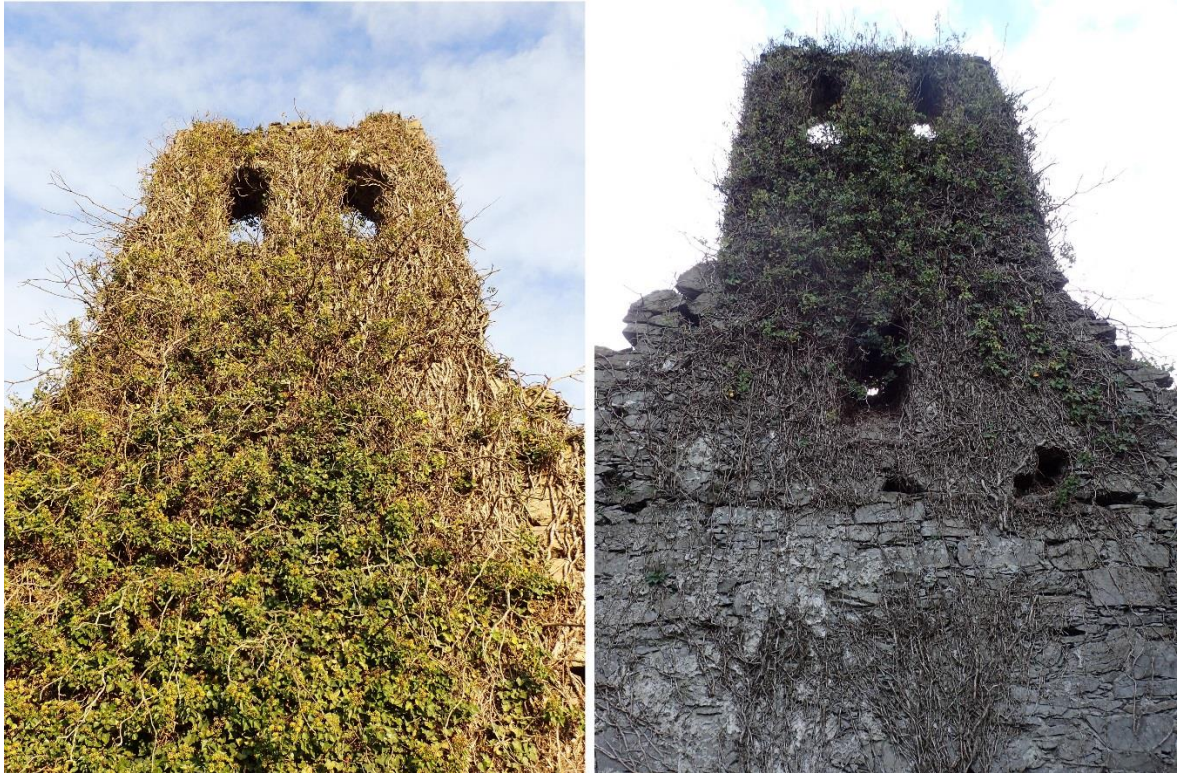
Fig.13: General views of external (left) and internal (right) faces of the bellcote showing the extent of ivy growth. The ivy has been cut in the past in an attempt to kill it off. Unfortunately, this has resulted in the plant rooting within the wall and continuing to thrive.

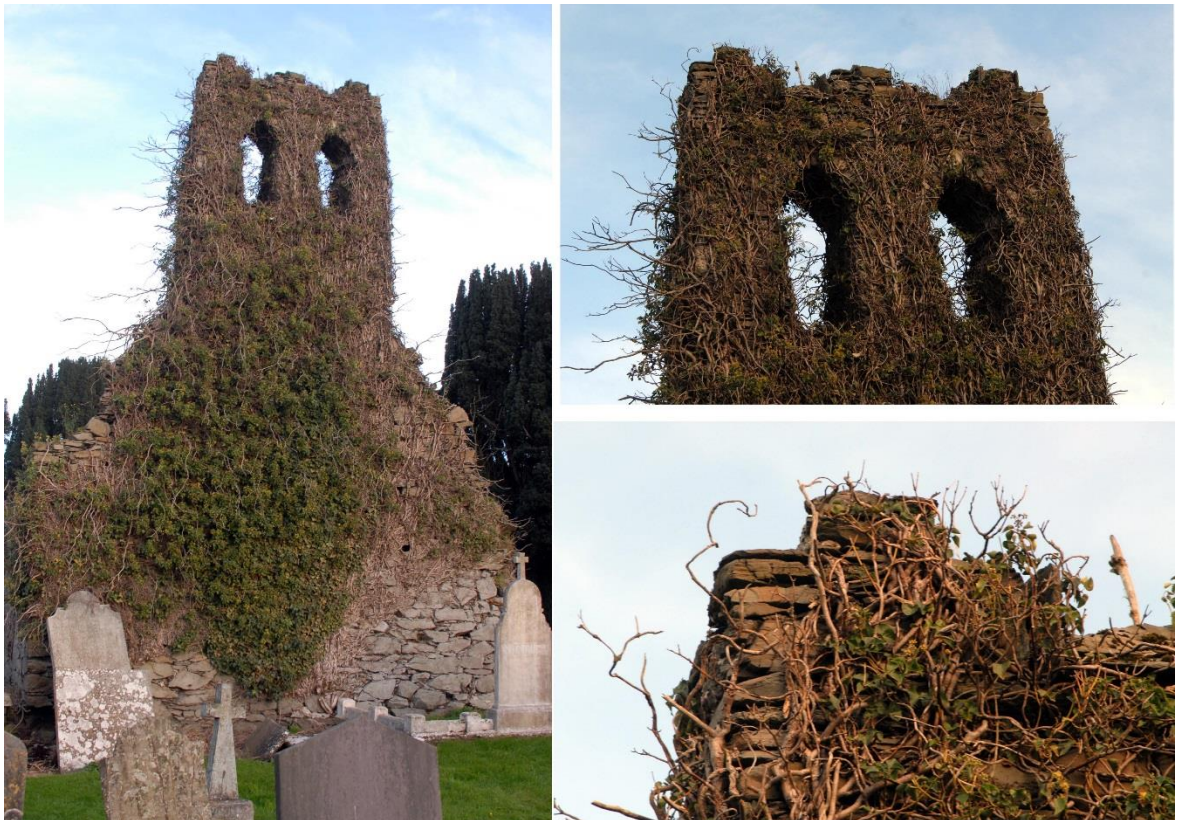
Fig.14: The ivy extends to the top of the bellcote. The masonry shows dry joints throughout, and further growth of the ivy should be expected to result in dislodgement and falls of masonry.

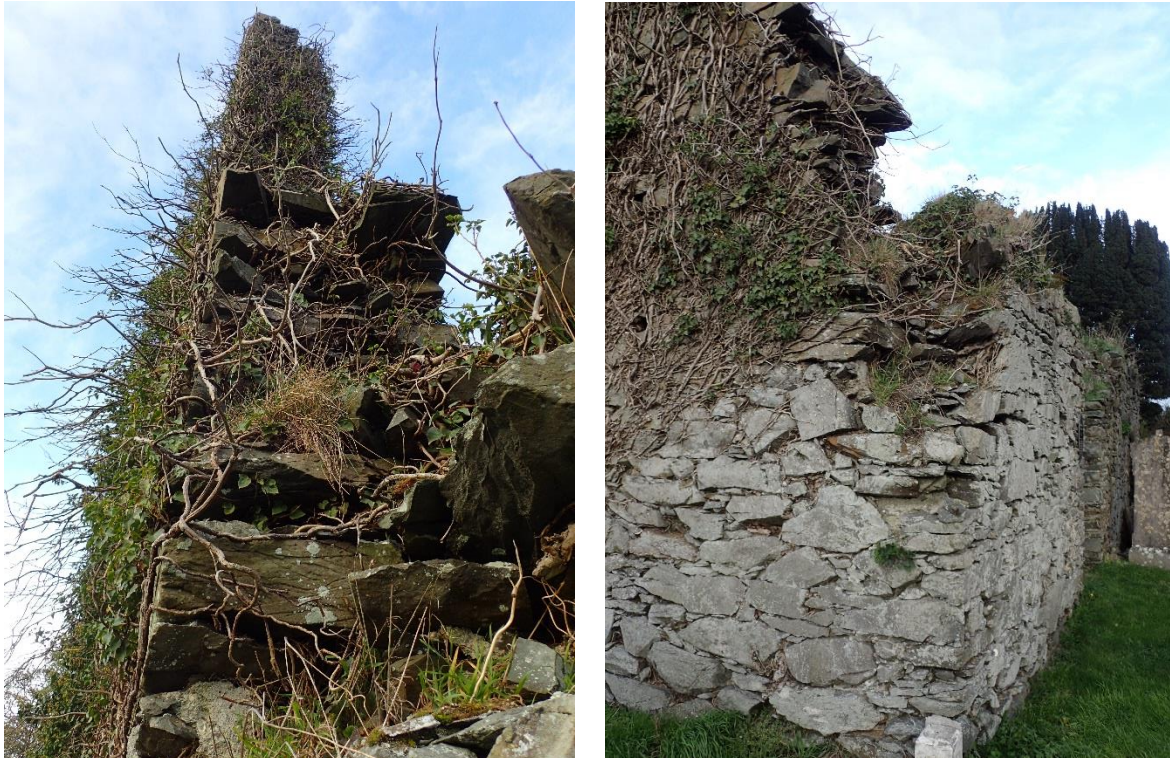
Fig.15: Both edges of the gable show exposed wall core and loose and dislodged masonry (left) with the south-east corner showing unravelling of the masonry and dry joints throughout.

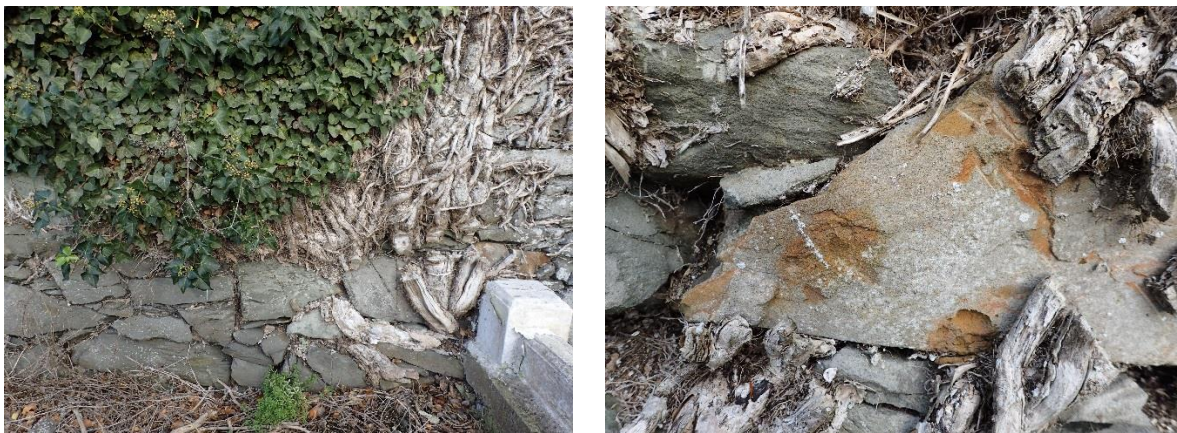
Fig.16: The ivy was cut close to the ground at some time in the recent past in an attempt to kill the plant. Unfortunately, this resulted in the ivy rooting into the masonry fabric and continuing to grow. Note the strike marks (right) where tools struck the stone.

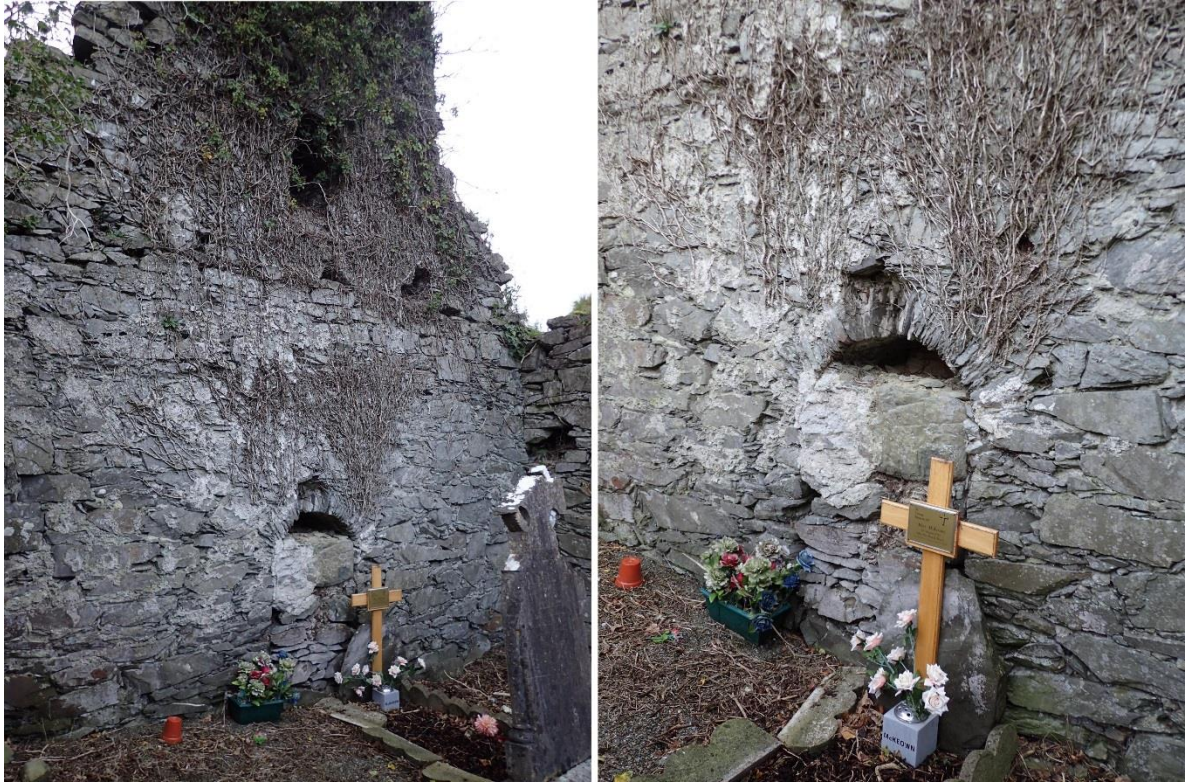
Fig.17: The internal face of the west gable wall shows a blocked-up west doorway, with recent burials at the foot of the wall. Traces of a lime-based plaster survive on the face of the wall indicating that the interior of the church was formerly plastered (see north elevation also). Note recent burial.

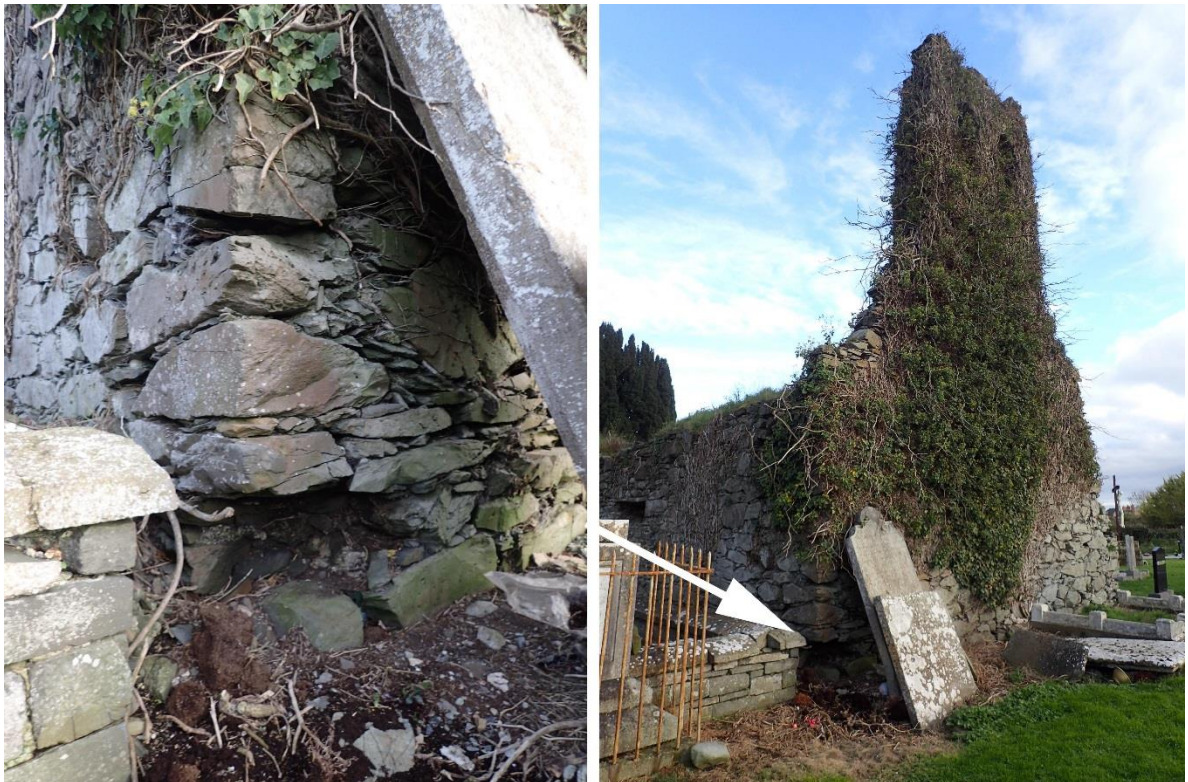
Fig.18: The north-west corner of the west elevation shows lost quoins, with resultant lack of support for the masonry above. Note the deep dry joints between the stones above. The large quoins show packing of smaller slately stones. However, the exterior of the church would originally have been lime rendered or washed externally and these stones would not have been visible when the parish church was first built.

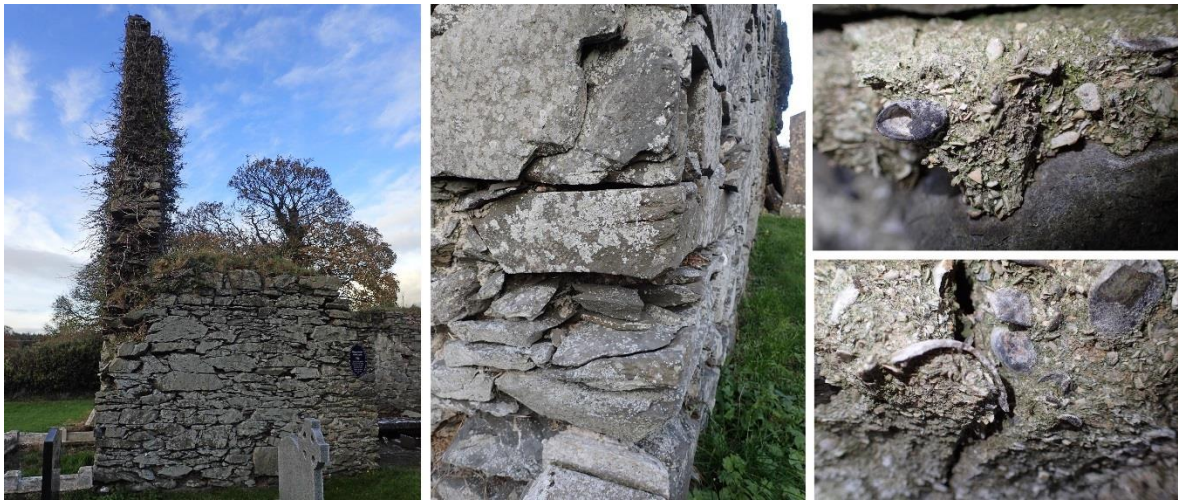
Fig.19: The western portion of the wall shows deep dry joints and partial collapse at the junction with the west gable wall (see Figs.12 & 15). The bedding (c.250mm within the joint) is a shell-rich mortar. The stone surface along this elevation is coated with a thin coat of lichen.

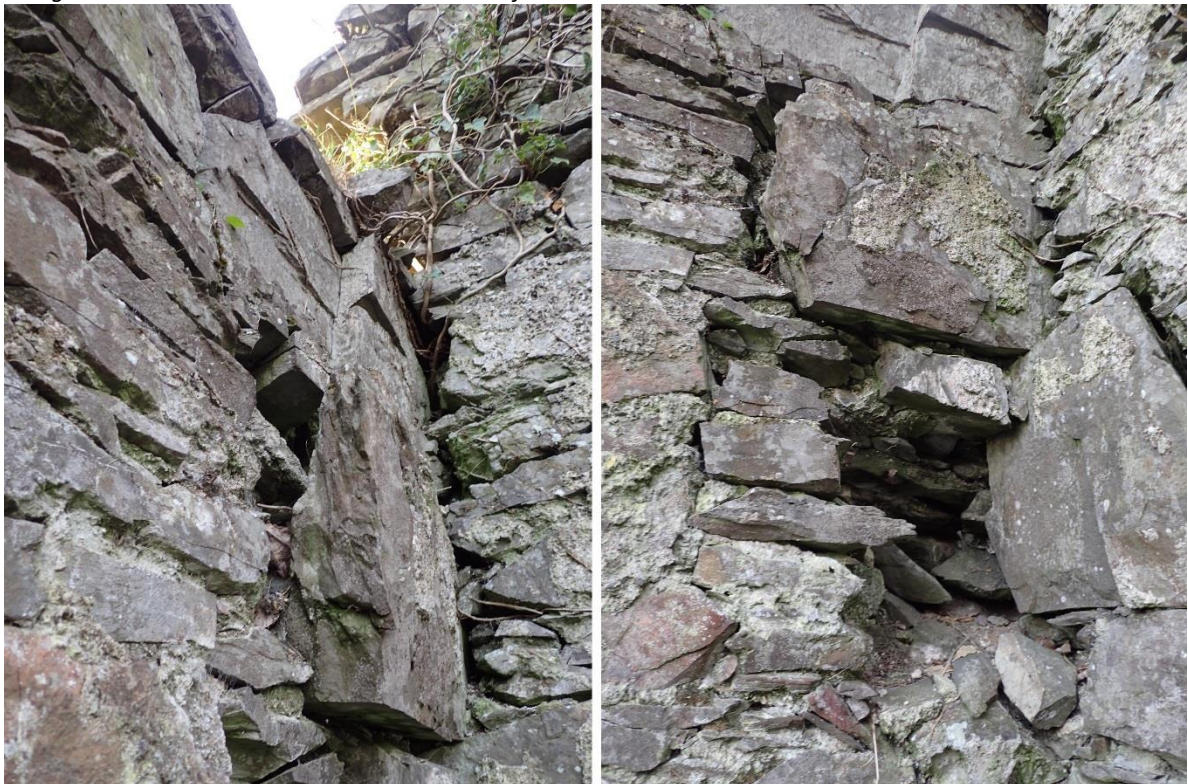
Fig.20: The internal (north face) of the junction between the south elevation and the west gable wall shows a loss of bonding and the dislodgement of stone. There is inadequate bond between the inner face of masonry and the wall core, resulting in large stones moving and detaching from the face of the wall.

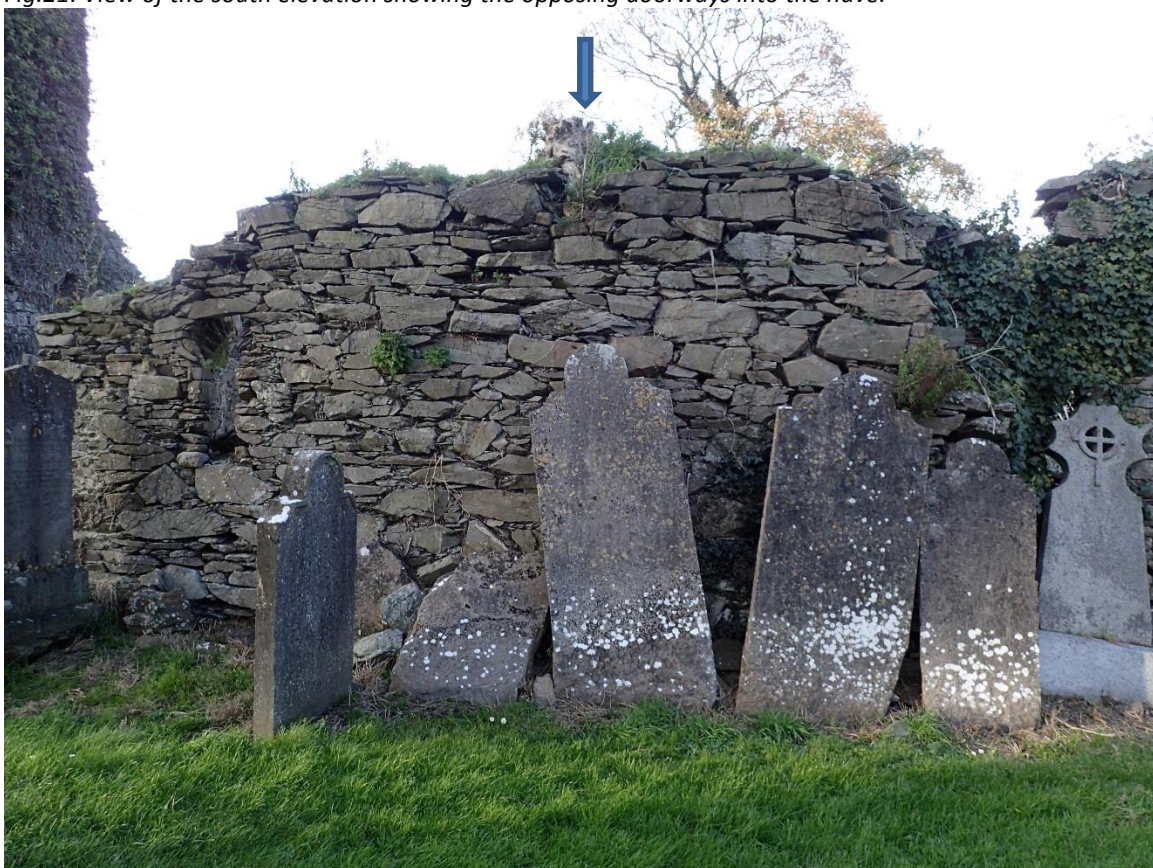
Fig.22: Graveslabs propped against the nave. Note dry joints, stump (arrow) vegetation & failure of SE corner.

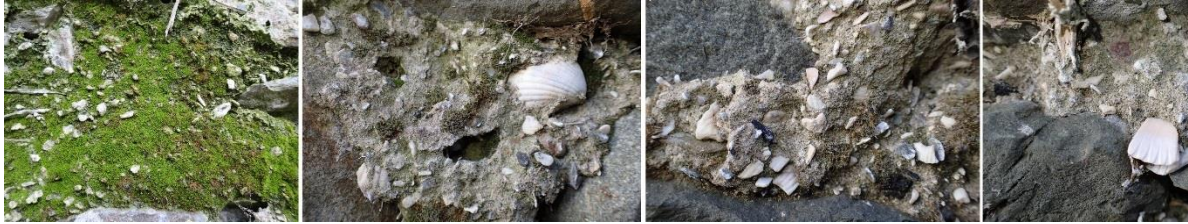
Fig.23: Detail of shell-lime mortars in the south-wall of the nave and chancel, used as bedding and plastering mortars (the greenish biofilm is from saturated masonry within a window embrasure).

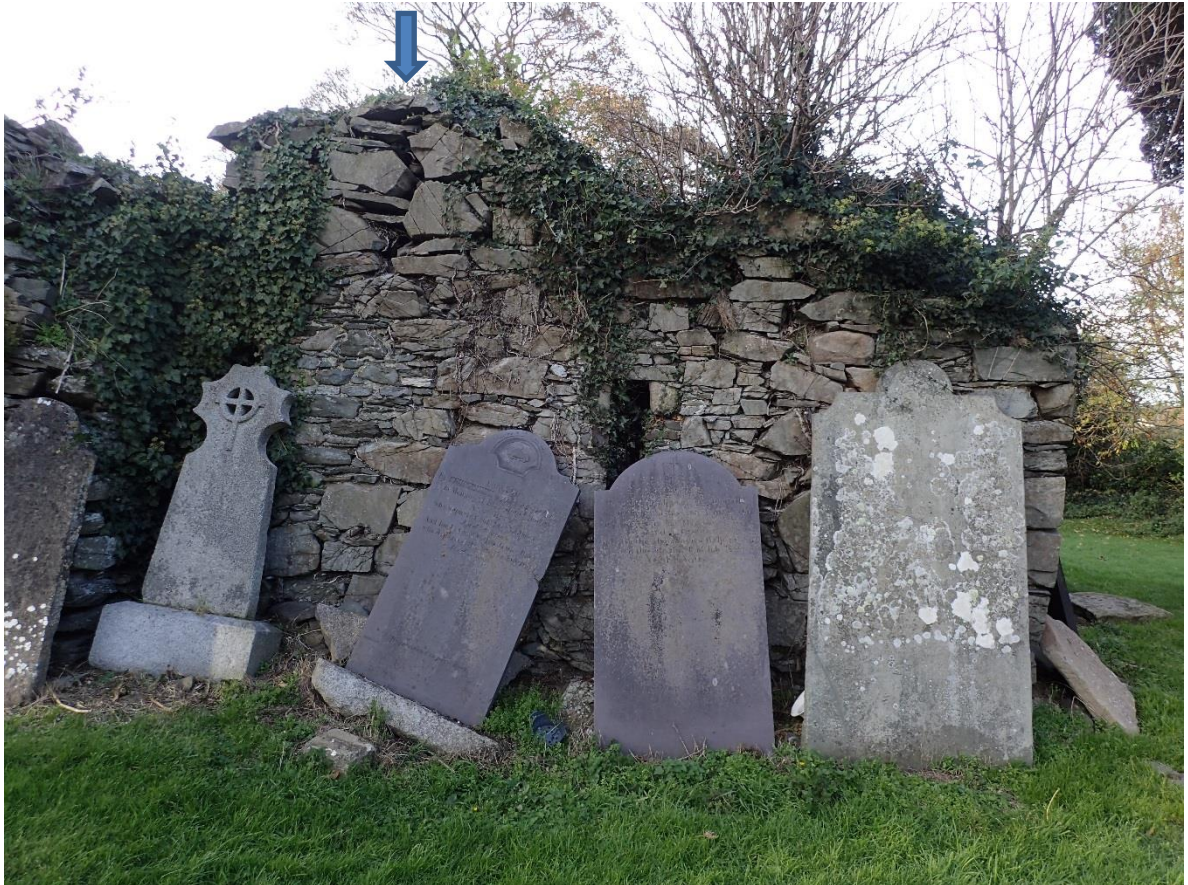
Fig.24: Graveslabs propped against the chancel, with a large structural crack forming at the wall top (arrowed), shrubs and ivy growing along the head of the wall and dry joints throughout.

It should be noted that large shrubs or trees are growing in two locations at wall-top level of the chancel – at the head of the east wall, and at the head of the south wall (Figs.11,24 & 30). The root systems of these plants should be expected to have penetrated to some depth into the masonry.

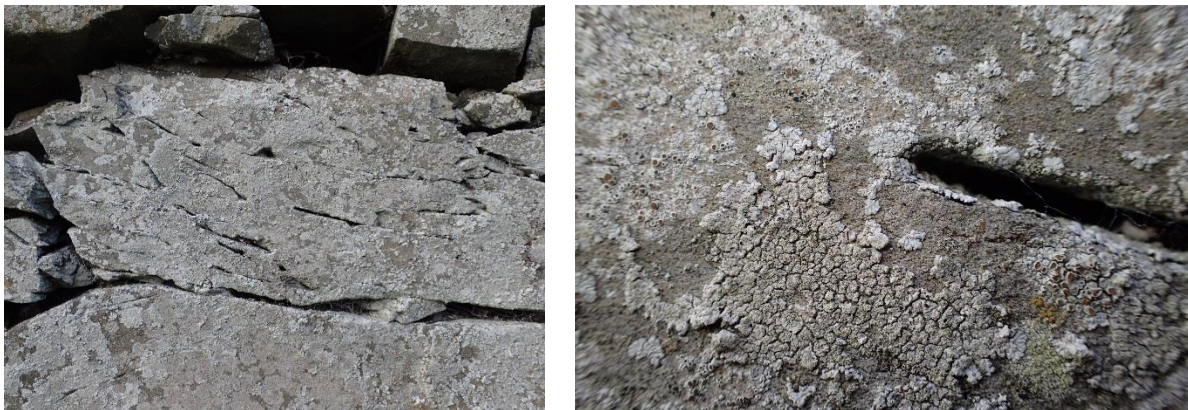
Fig.25: The greywacke shows a coating of lichen in places. These are indicators of good air quality and do not currently need to be removed.

Lichens are present, particularly on the south elevation of the building (Figs.25,28). These are relatively benign and are not associated with any stone decay. There is **no reason to clean off or remove the existing lichens** and these should be allowed to remain throughout.

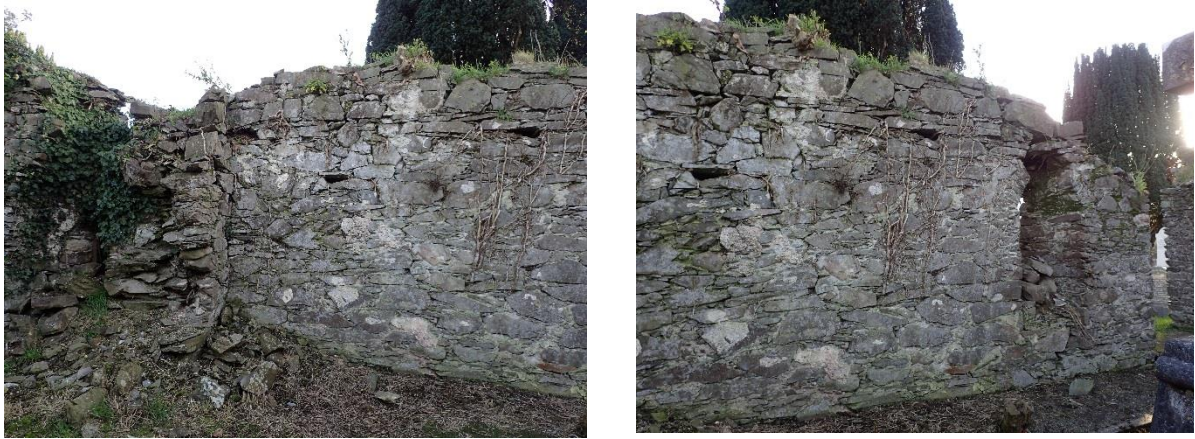
Fig.26: The inner face of the south wall of the nave showing remnants of a lime-based plaster, a collapsed chancel arch, and plant growth along the wall-top.

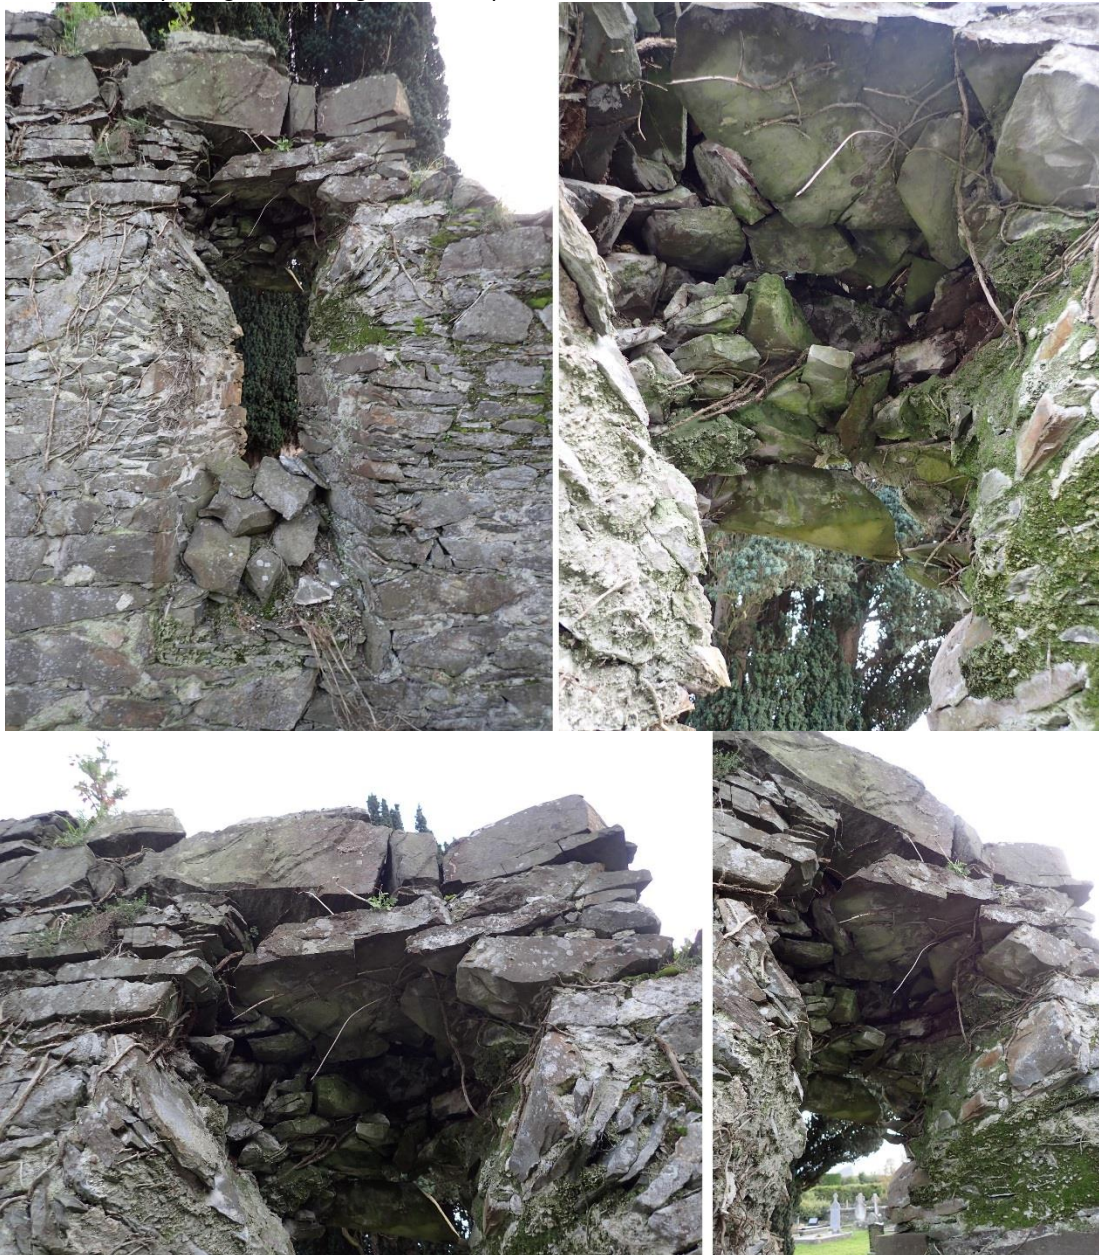
Fig.27: Nave, south elevation: failing window head.

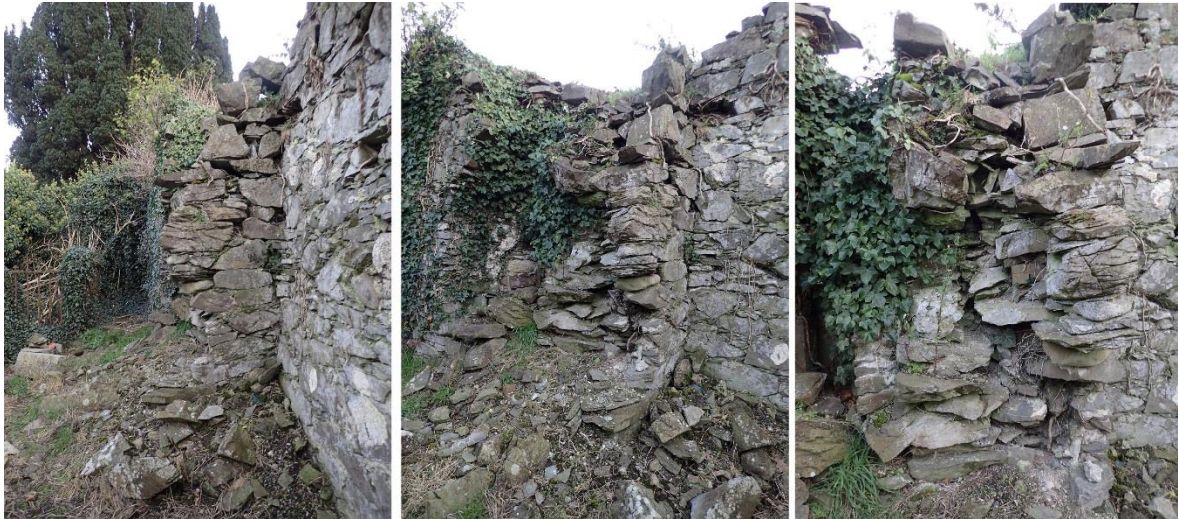
Fig.28: Collapse of the chancel arch showing loss of mortar 'hearting' from the wall-core accompanied by deep dry joints, new ivy growth and the dislodgement of masonry. A pile of collapsed masonry lies at the foot of the wall and within the chancel³³.

³³ Collapsed stone should be retained on site as it can be used for repair and stabilisation.

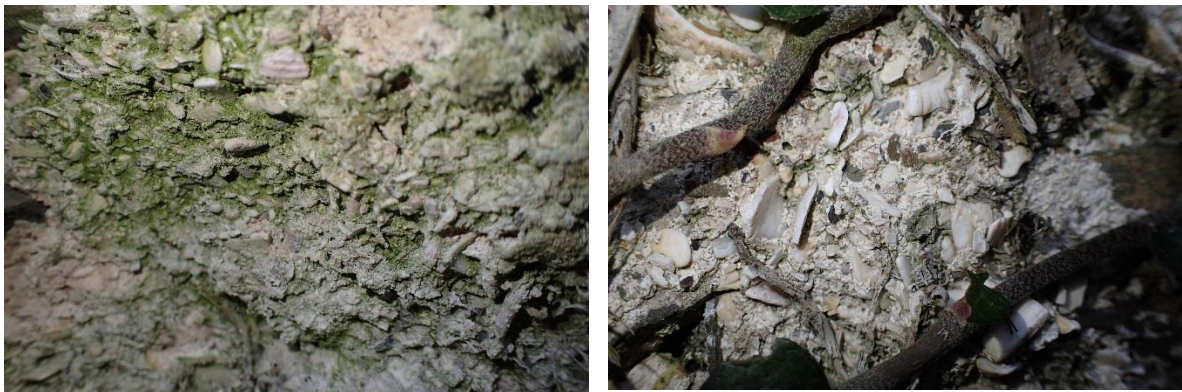
Fig.29: The lime plaster within the splayed window in the south wall of the nave has a shell-rich lime plastering mortar (left). The bedding within the exposed wall core of the collapsed chancel arch also contains a shell-rich lime-based mortar (right).

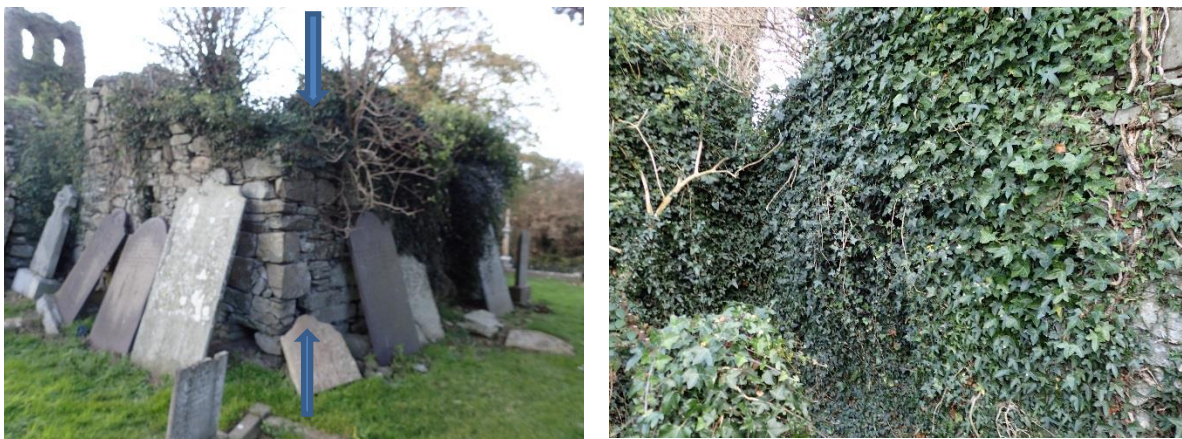
A large open structural crack can be seen at the south end of the east elevation. This appears to be the result of the loss of bond between the outer face of the masonry with the wall core (this process is explained in more detail in Section 4). Some of the stones show cracking from mechanical stress (Fig.32).

Fig.30: A structural crack is opening up on the south side of the chancel as the outer face of the wall detaches from the wall core (arrowed). Graveslabs have been propped against all three sides of the wall. However, these do not offer any support to the masonry, and are themselves at risk of fracturing and breaking should any weight from the masonry pass to them.

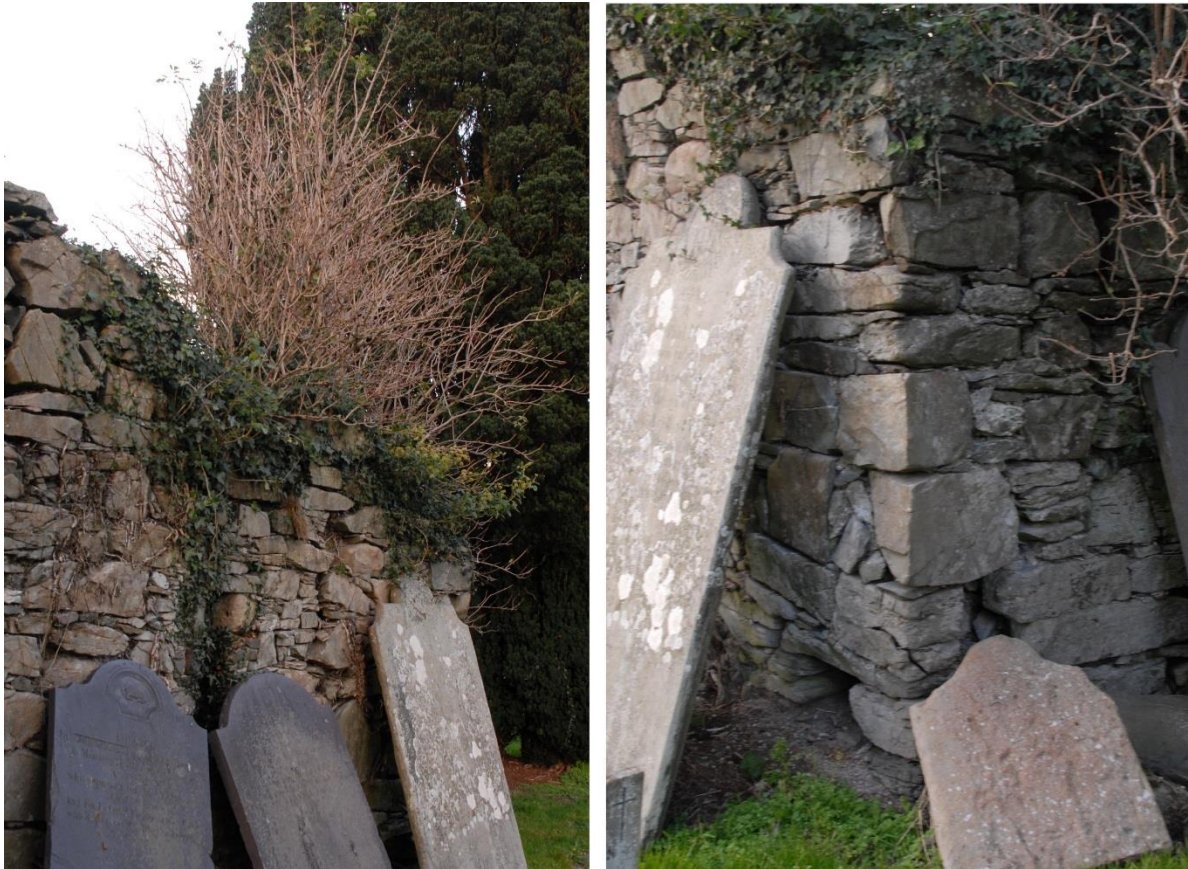
Fig.31: Disruption of the south-east corner of the chancel as a result of dry joints and invasive plant growth.

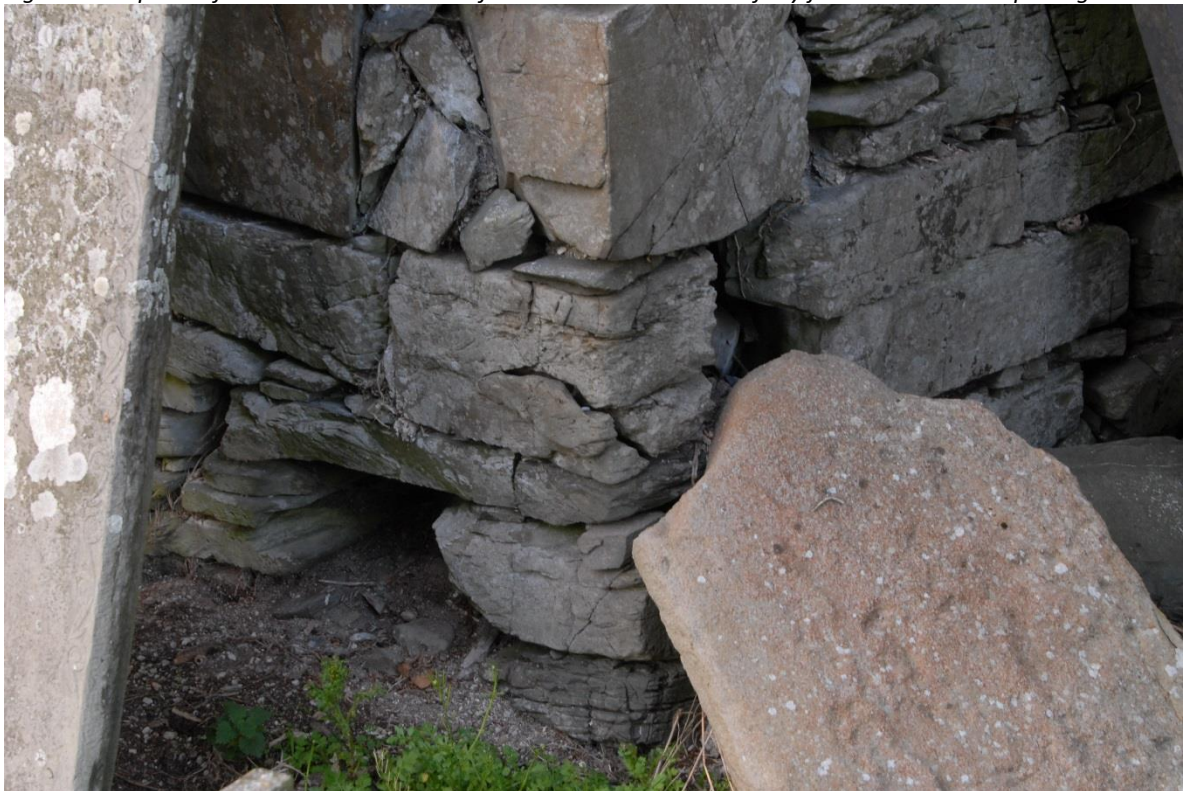
Fig.32: Mechanical stress leading to cracking of quoins at the SE corner of the chancel.

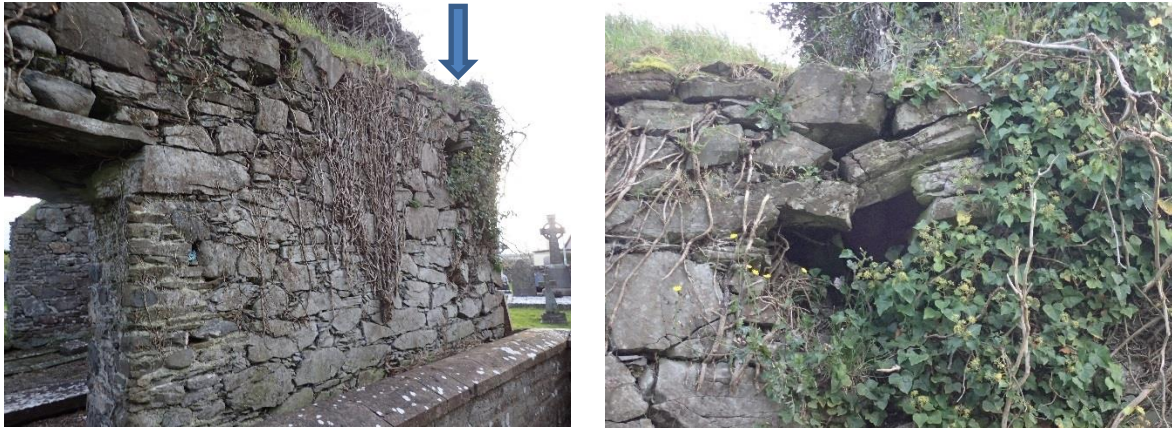
Fig.33: The western end of the north wall of the nave shows an open structural crack and collapse at the top of the wall (arrowed, see Fig.18 also). The masonry on the inner face of the wall also shows dry jointing, disruption of the wall-top, and the detachment of stones.

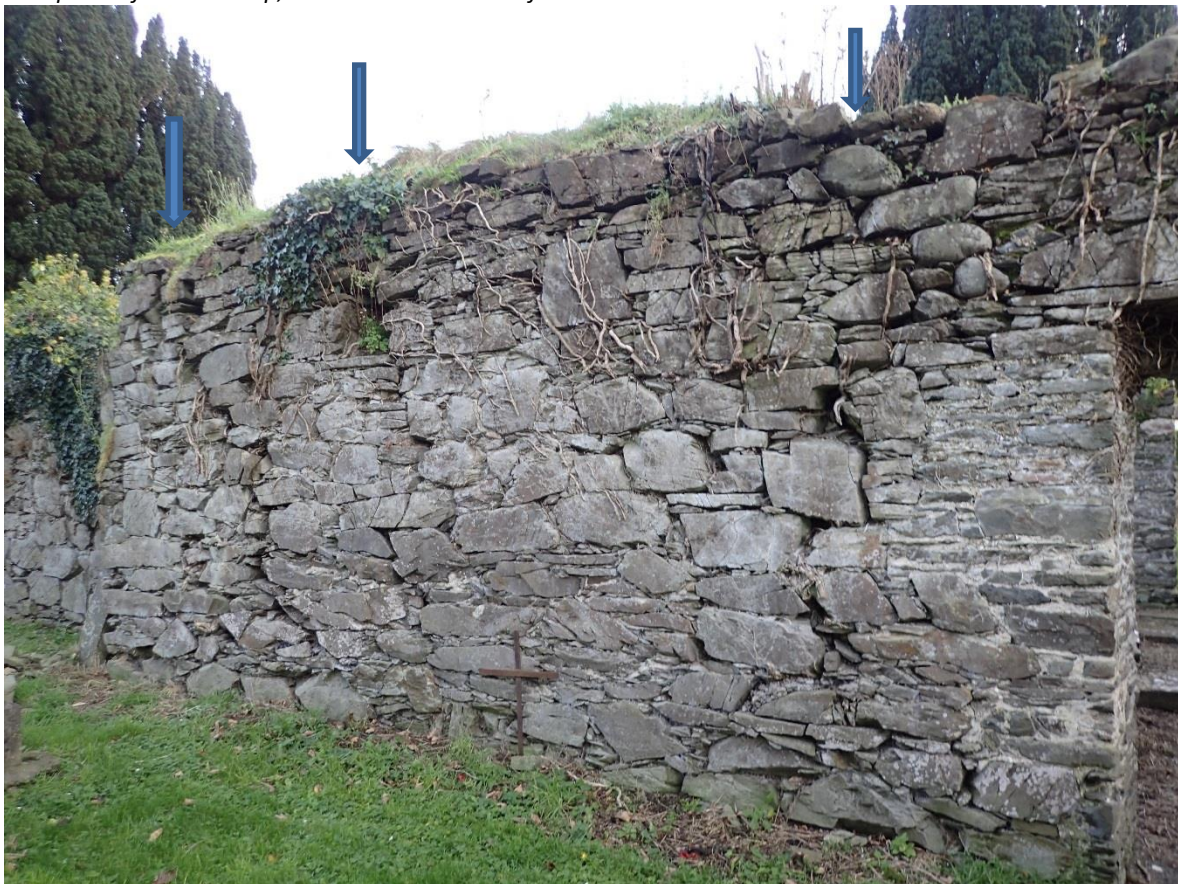
Fig.34: This section shows three vertical cracks (arrowed). Corresponding cracks and areas of collapse can be seen on the internal face (Fig.36) with stones at the lower quoins of the north-east corner of the nave showing deep dry joints and cracks caused by mechanical stress (Fig.43).

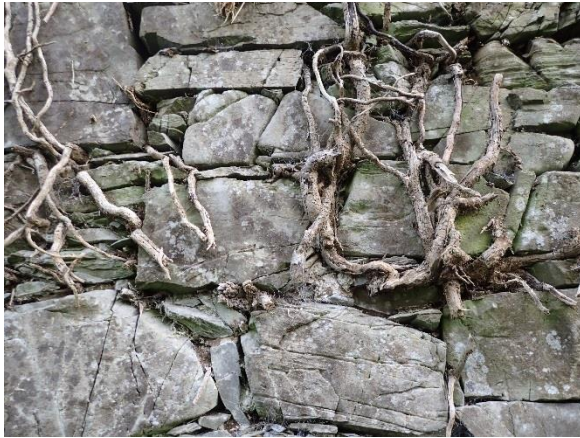
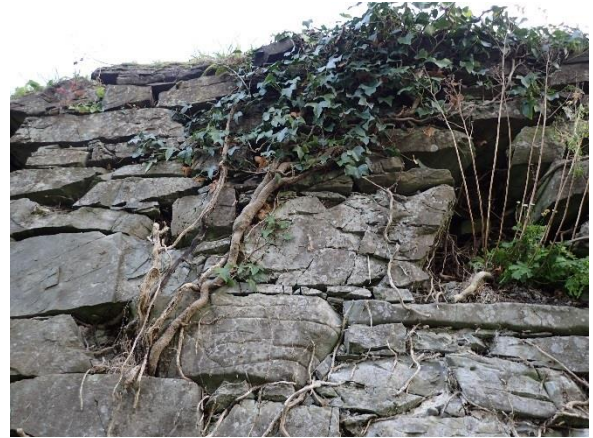
Fig.35: The ivy has penetrated deeply into the core of the masonry. The ivy was previously cut off above the root. Unfortunately, this allowed the mature plant to root within the wall where it continues to thrive. The wall top is exposed and the joints are dry allowing significant moisture ingress (which in turn accelerates the process of deterioration).

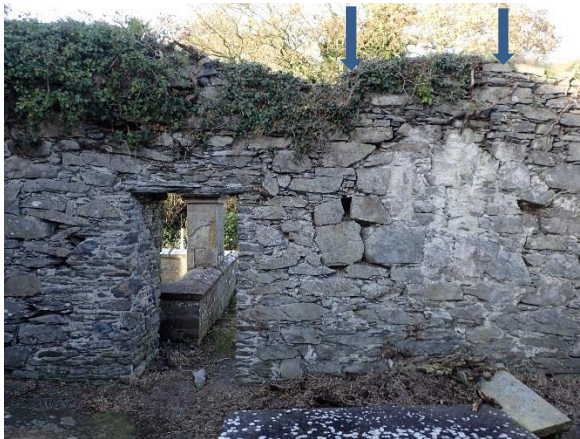
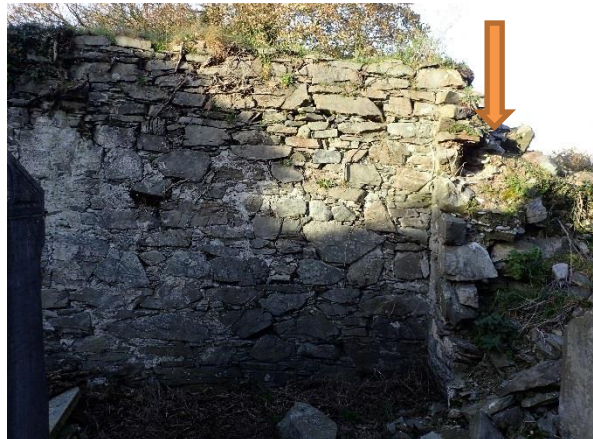
Fig.36: The inner face of the north wall shows opening cracks corresponding with those seen externally (Fig.34). The chancel arch has collapsed (orange arrow) with corresponding disruption seen on the outer face of the nave (Figs.42 & 44).
