HAGGARDSTOWN OLD CHURCH CONSERVATION AND MANAGEMENT REPORT

For Blackrock Tidy Towns

November 2020

3. Condition Survey

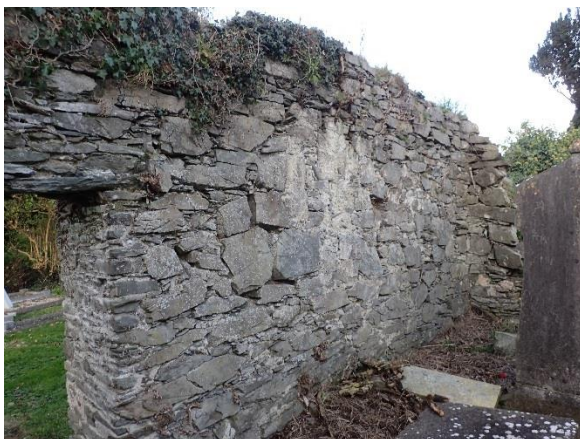
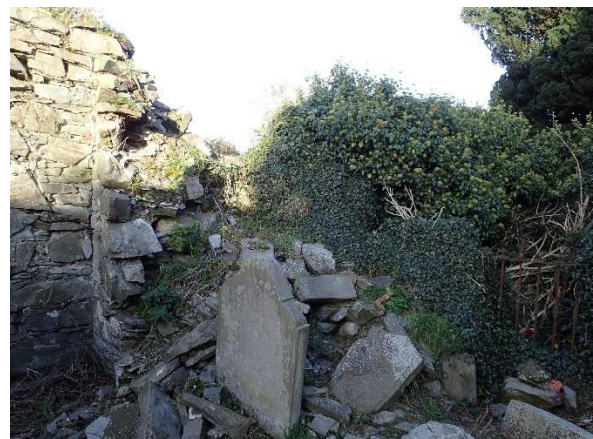
Fig.37: The inner face of the north elevation retains traces of lime-based plaster (which have assisted in protecting the masonry, see Fig.38). The chancel arch has collapsed exposing the wall core (right). Note that the inner face of the chancel is entirely concealed by invasive vegetation.

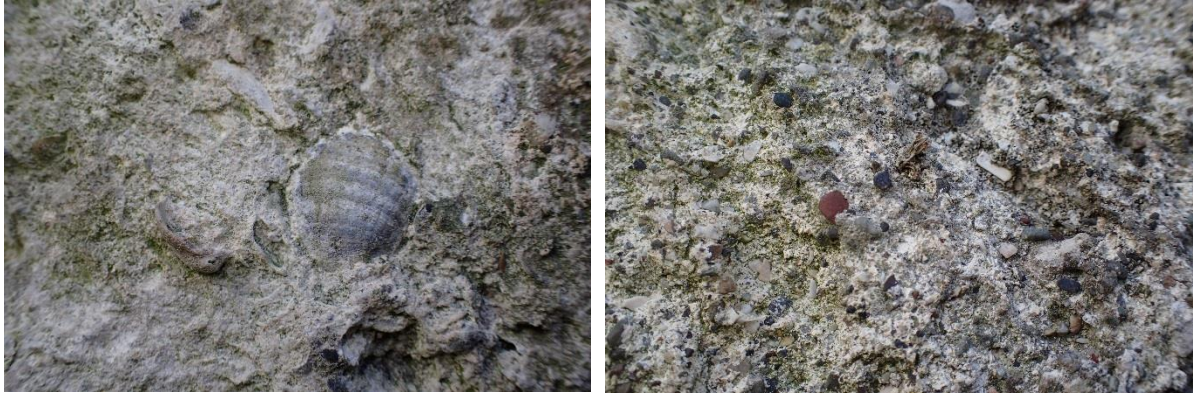
Fig.38: Detail of the shell-lime plaster seen on the inner face of the north wall of the nave.

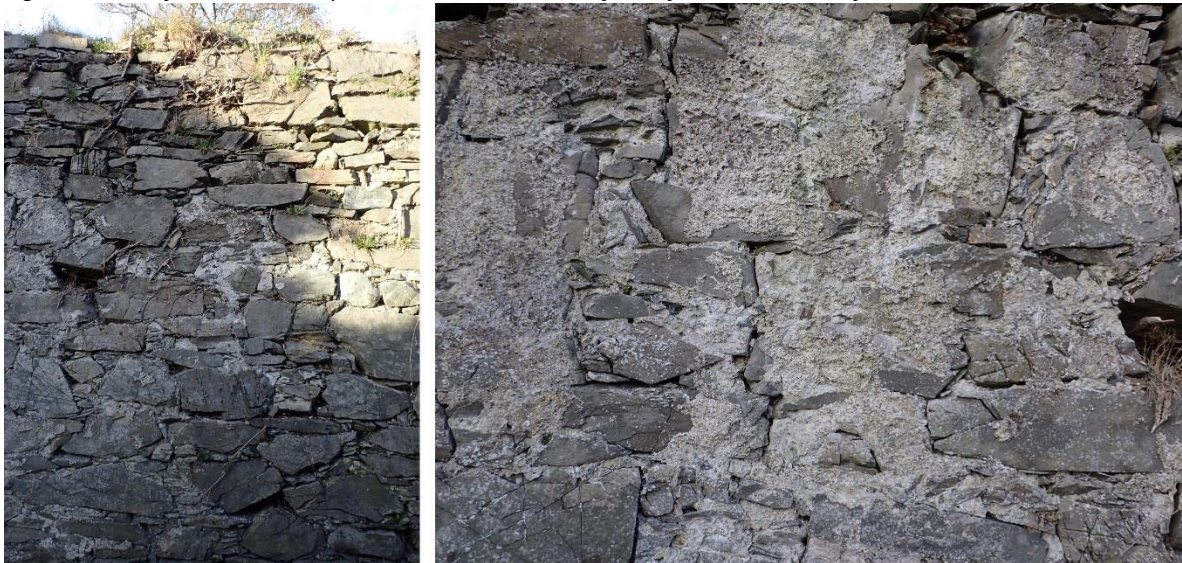
Fig.39: General view of the lime-based plaster basecoat adhering to the inner face of the north wall.

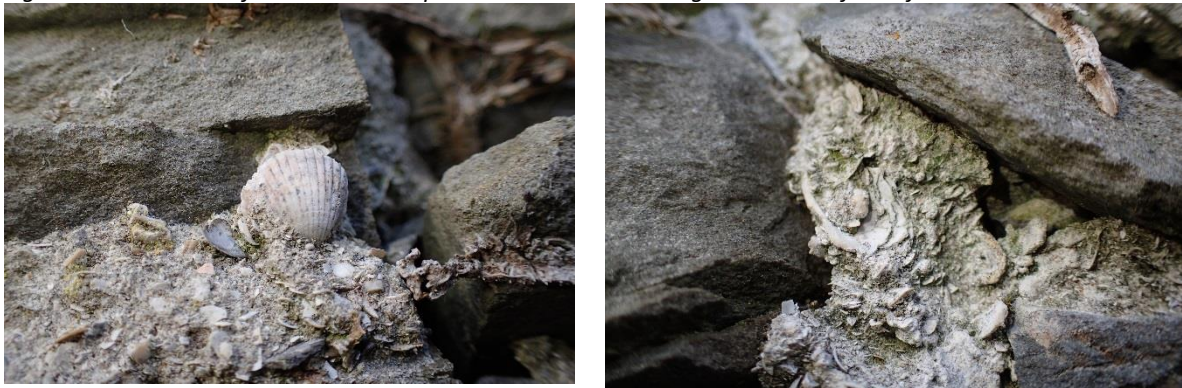
Fig.40: Shell aggregate in the lime-based bedding mortar of the north wall of the nave.

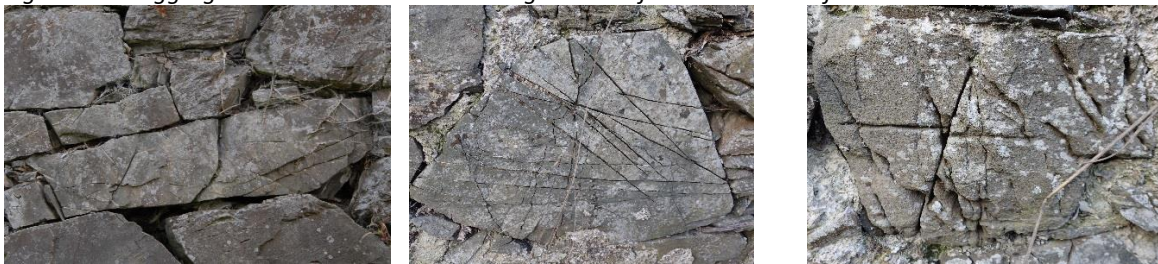
Fig.41: The greywacke masonry blocks show inherent stone decay forms and weathering; but also cracking induced by mechanical stress as the outer face detaches from the wall core.

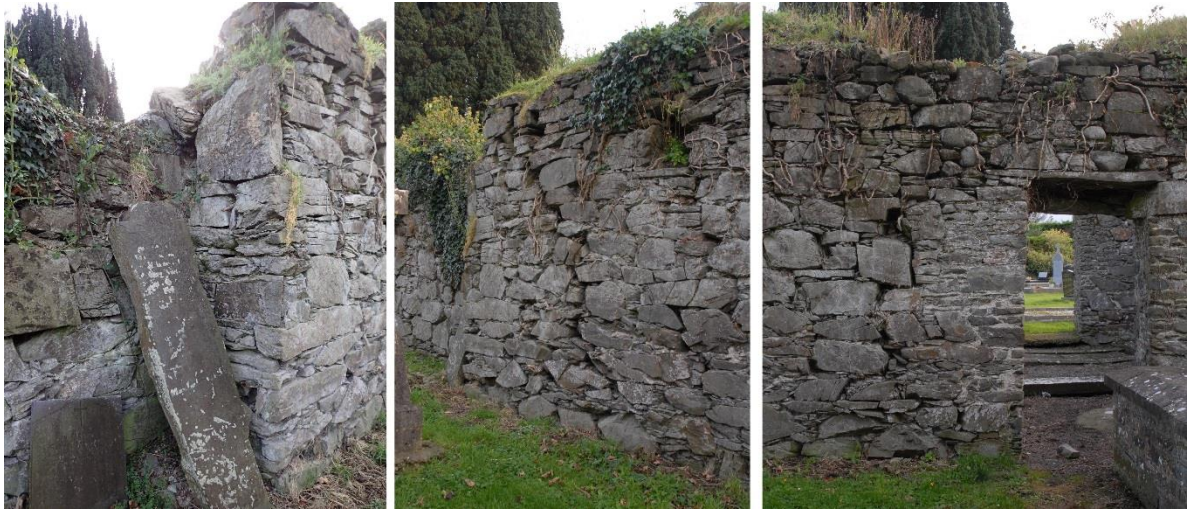
Fig.42: Cracking can be seen along the north elevation.

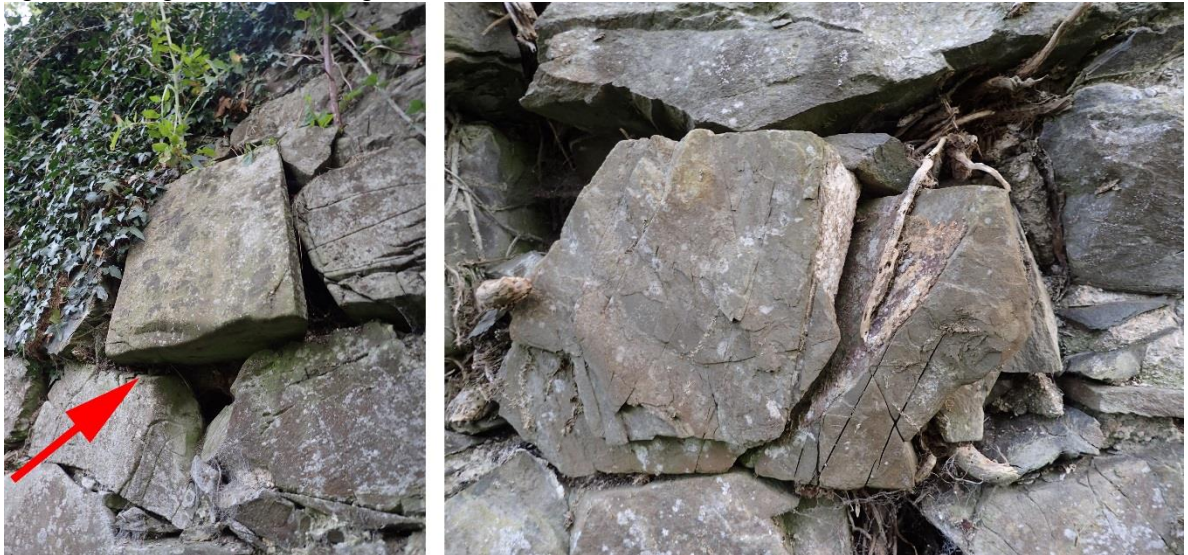
Fig.43: The cracks are associated with dry jointing, dislodged stones (left) and cracked stones (right).

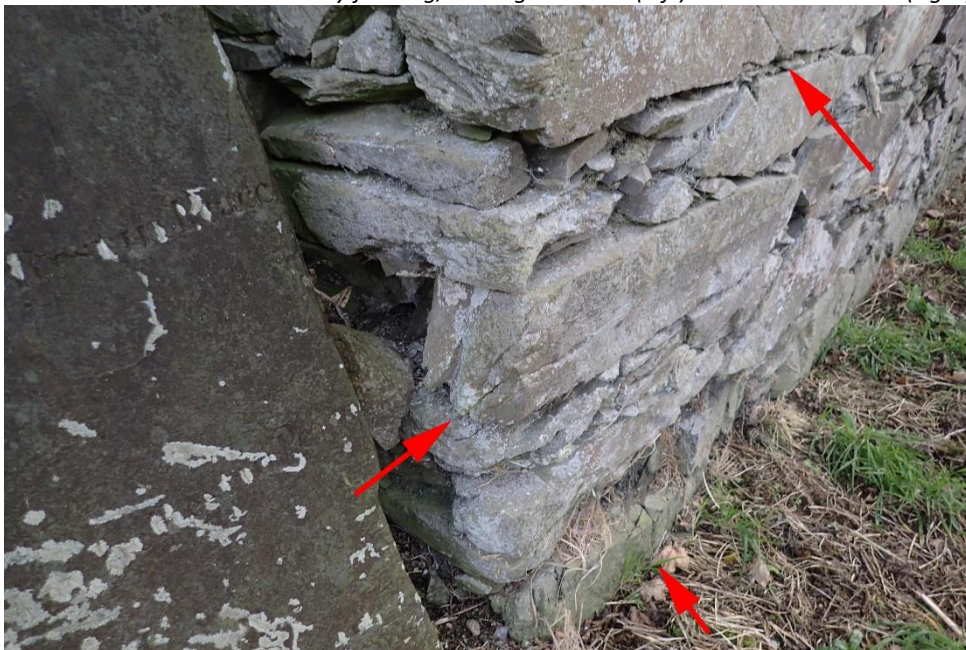
Fig.44: Dry joints and cracks caused by mechanical stress (arrowed).

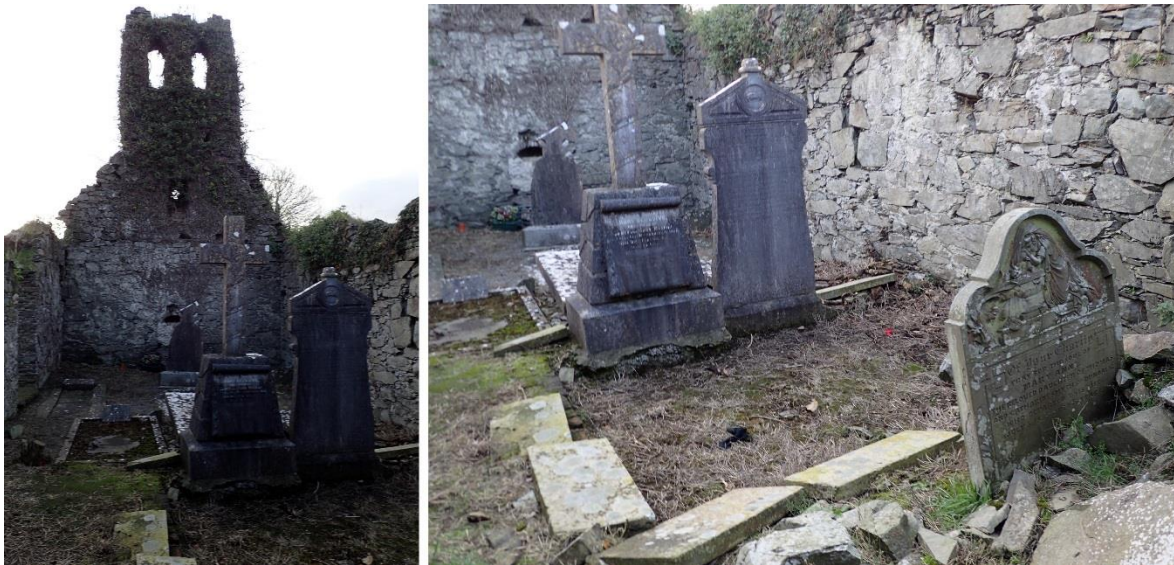
Fig.45: General view of memorials within the nave of Haggardstown Old Church. Care should be taken not to disturb any burials during any necessary repair or stabilisation works.

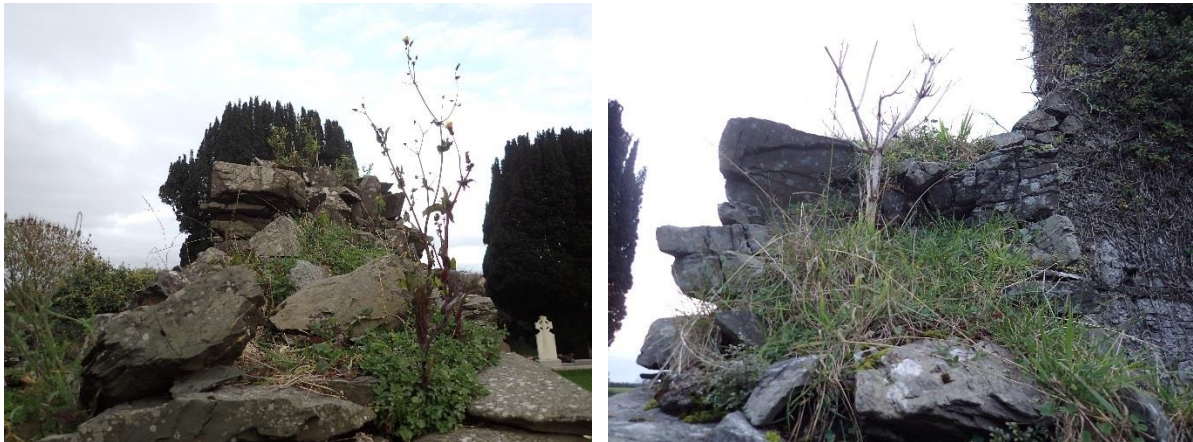
Fig.47: Grass and flowering plants on the broken and uneven wall-tops of the south elevation of the nave.

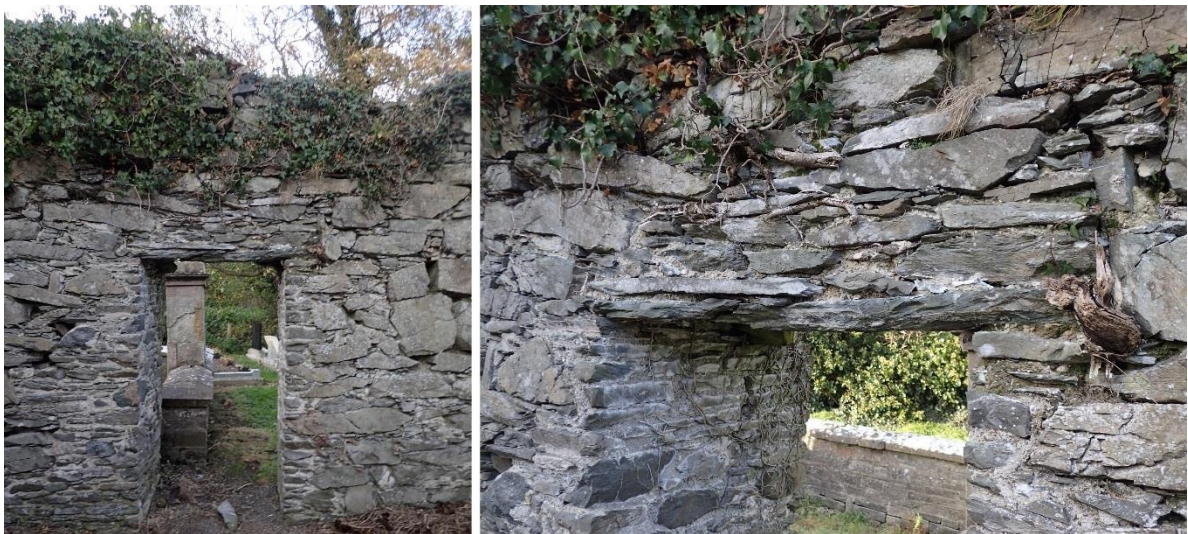
Fig.48: 1880 doorway in the north wall of the nave. The lime leaching indicates significant moisture ingress³⁸.

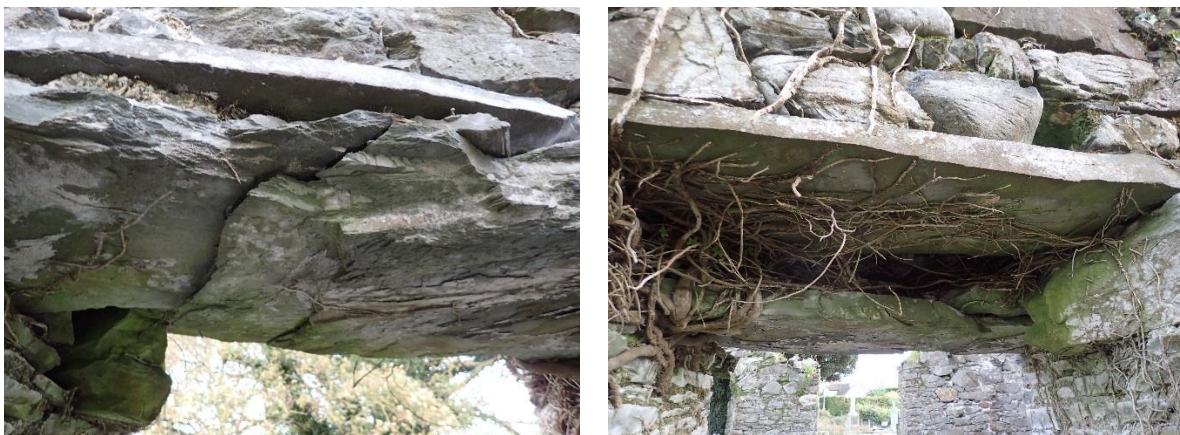
The two opposing doorways in the nave were repaired using a shell-lime mortar in the 1880s (Figs.33,34,36). The lintel of the north doorway is cracked (Figs.48,49) with ivy growing above and invasive roots visible.

Fig.49: Detail of the 1880 doorway showing cracked stone lintel and invasive roots.

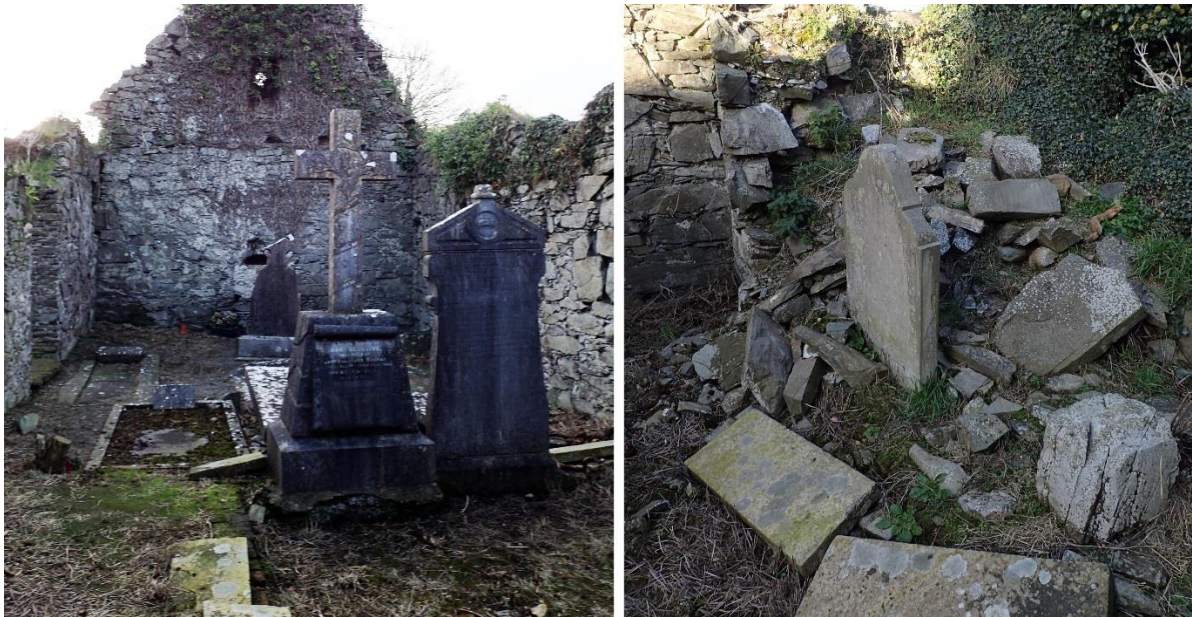
Fig.52: The interior ground surface is uneven, with gravemarkers, collapsed rubble and vegetation.
