HAGGARDSTOWN OLD CHURCH CONSERVATION AND MANAGEMENT REPORT

For Blackrock Tidy Towns

November 2020

3. Condition Survey

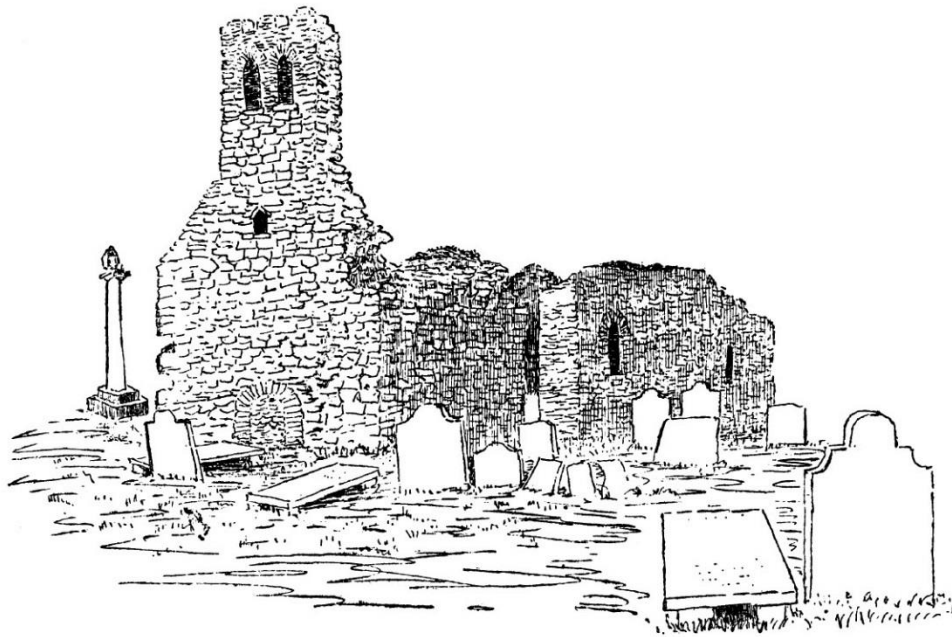
Fig.7: 1934 drawing of Haggardstown Old Church showing the blocked-up west doorway, and damage to the south-west corner where the gable meets the south wall of the nave. The shading may indicate vegetation.

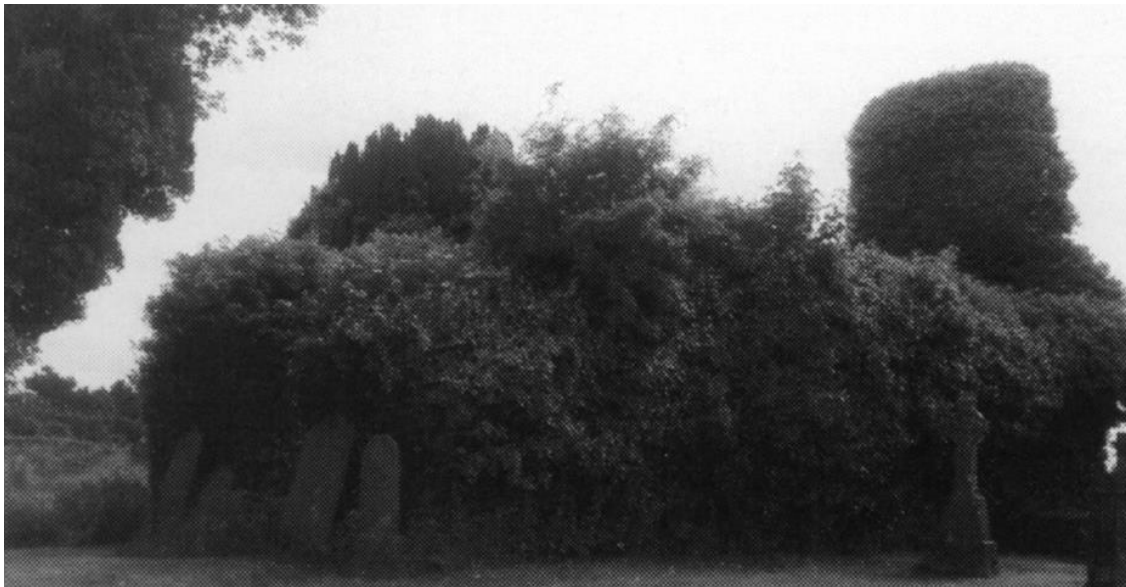
Fig.9: Photo of Haggardstown Old Church by H. O'Sullivan (2003) showing the ivy enveloping the building.

Graveslabs have been propped against all three walls of the nave since before 2003 (Fig.9) though the ivy has been removed in recent years from the outer face (Fig.30). The east window has been entirely obscured by dense ivy, as has the internal face of the east chancel wall and the condition of the wall in these areas is unclear.

3.6.1 Vegetation: The ivy and other vegetation which previously enveloped the church (Fig.9) have been removed. The removal with little damage to the masonry and was a necessary step in safeguarding the church. However, the ivy and other plants had developed deep root systems which have penetrated into the masonry fabric; in turn allowing significant water ingress into the masonry, accelerating decay mechanisms. Over decades, the root systems have lifted and opened the joints, disturbing the wall-core. The cutting back of the mature ivy previously found on the buildings resulted in the dying off of much of these roots systems, leaving voids within the masonry. The south wall of the nave has a large stump at wall-top level (with associated root systems likely to extend >1.5m deep into the wall) and with live shrubs growing on the wall-top of the nave. **It will be necessary to carefully treat and remove all of the invasive vegetation as part of the conservation works.**

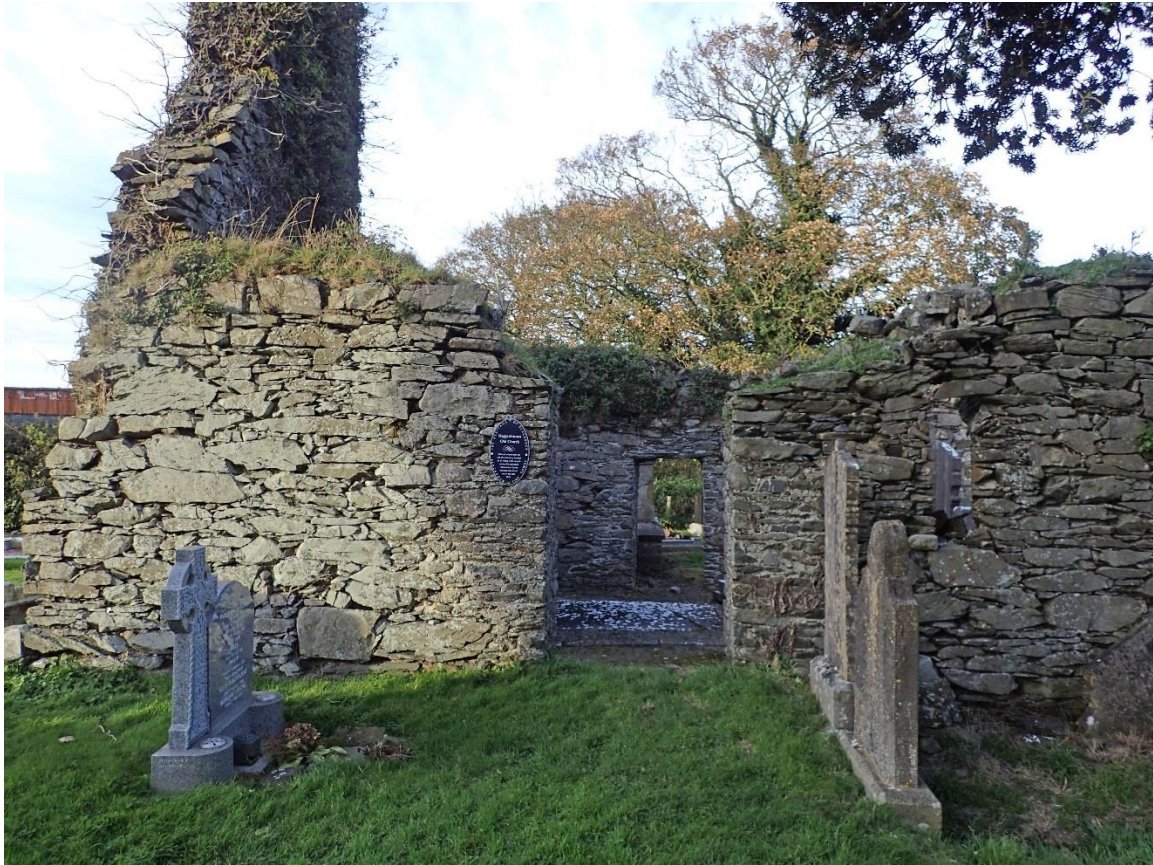
Fig.21: View of the south elevation showing the opposing doorways into the nave.

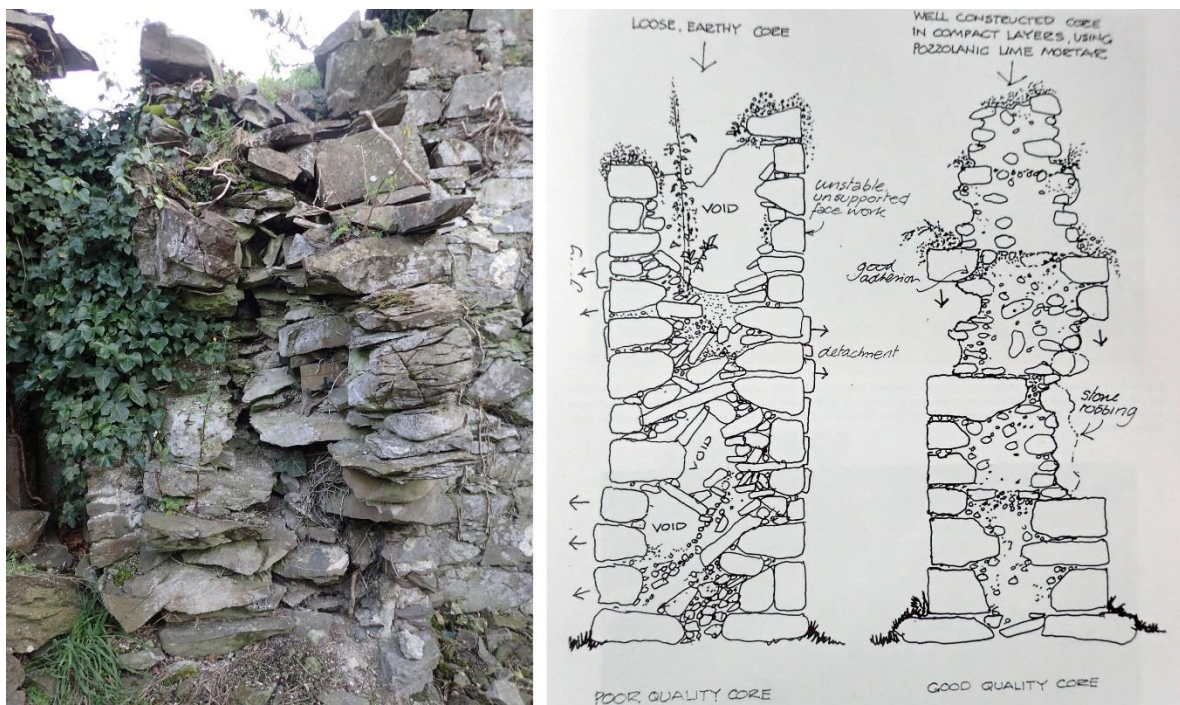
Fig.46: The walls of the church have a poor quality core, allowing displacement and detachment of individual stones, the opening of large structural cracks, the formation of voids within the wall, and unstable unsupported face work which is liable to detach. Source: Ashurst, Conservation of Ruins³⁷.
